TotalConcept

Implementation of the Total Concept method in twelve buildings in Northern European countries

Summary report of technical results

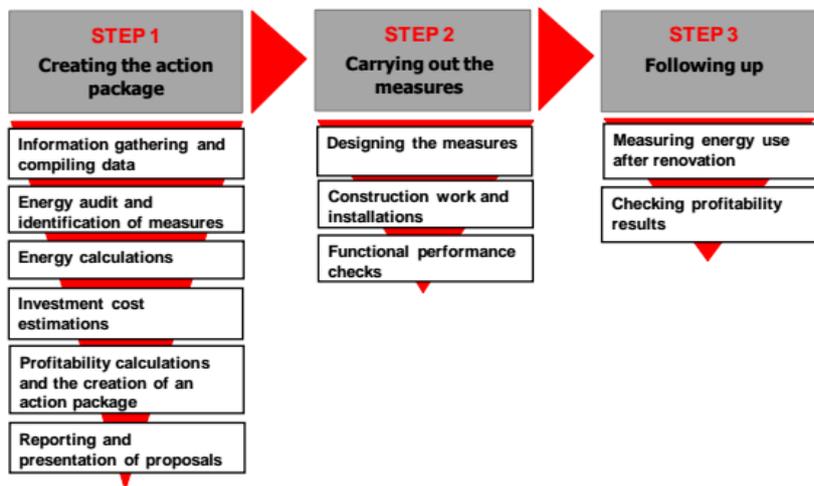
Figure 1.1 The three Total Concepts steps.

The Total Concept method consists of three steps (Figure 1.1). Twelve pilots building were analysed with the Total Concept method in step 1. The outcome of step one is a profitable action package. Eight of the pilots moved on with step 2 and step 3 and reduced energy use by implementation of the action package, or parts of it, within the timeframe of the Total Concept projects. The last four pilots might implement the action package, or parts of it, in the future.

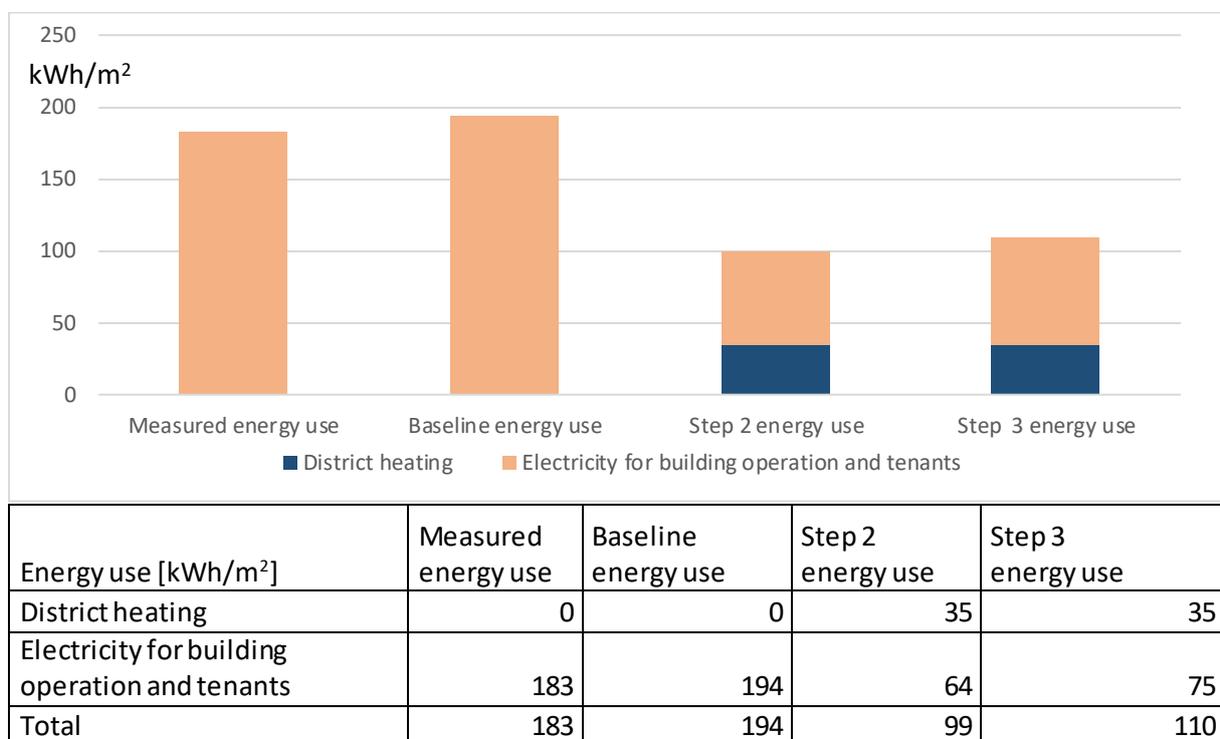
Figure 3.1 Outcomes in Step 3 compared to baseline.

One of the measures was a new ground source heat pump introducing thermal energy from a hydronic system. This thermal energy is denoted district heating in Figure 1 even though it is a local system for the building. There is no split between electricity for building operation and tenants.

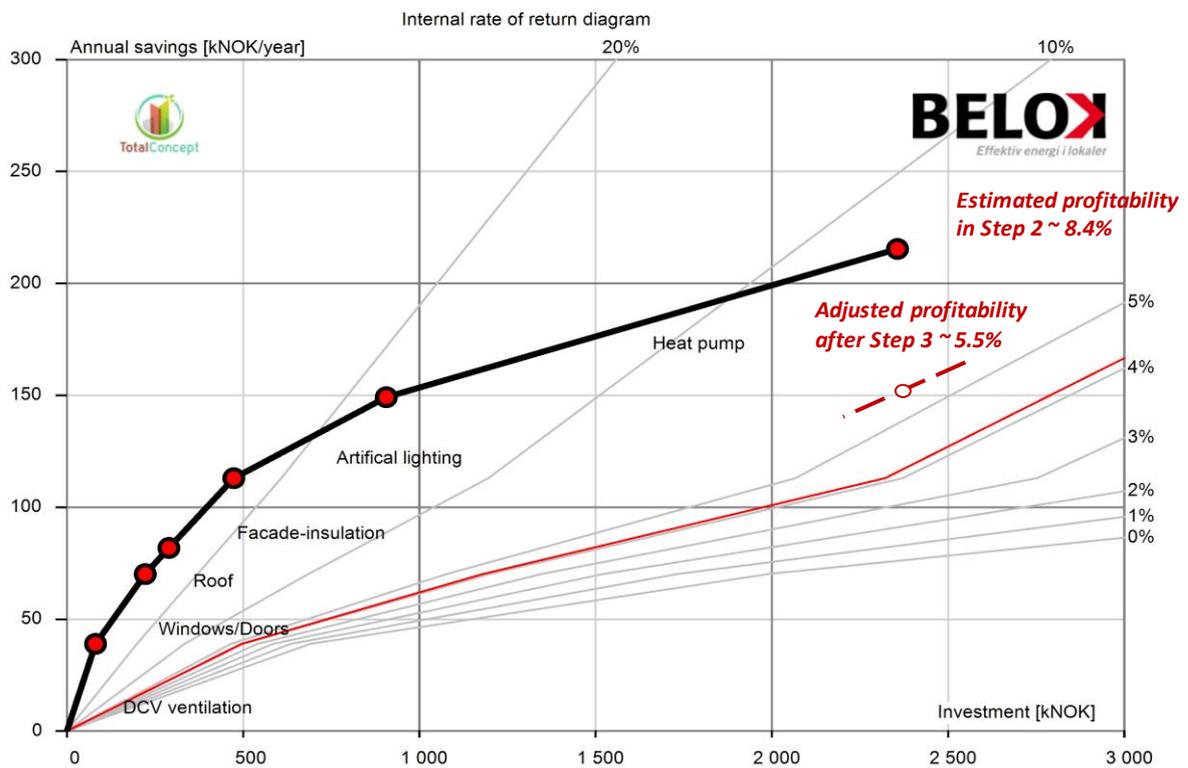
Figure 3.2 Outcomes of the profitability of the action package carried out at the Road office Steinkjer. Relative energy price increase is 2%. Estimated internal rate of return for the action package became 8.4%. Actual internal rate of return for the action package is approx. 5.5%.

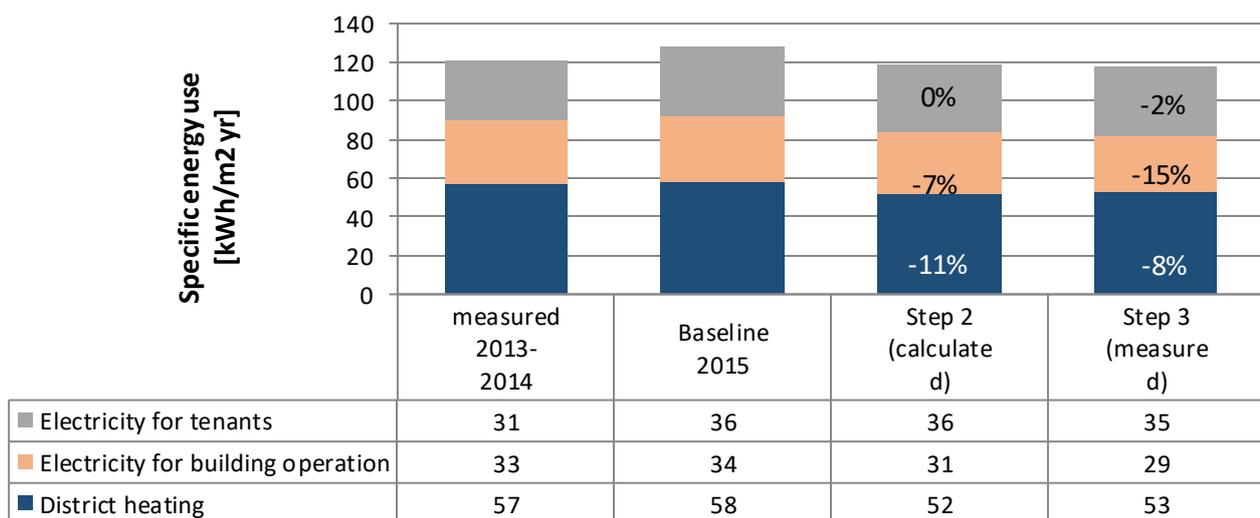
Figure 4.1 Total energy use of Högsbo. Measurement outcomes in Step 3 compared to estimated baseline in Step 1 and calculated values in Step 2.

Figure 4.1 presents the measurement outcomes in Step 3 compared to estimated baseline in Step 1 and calculated values in Step 2.

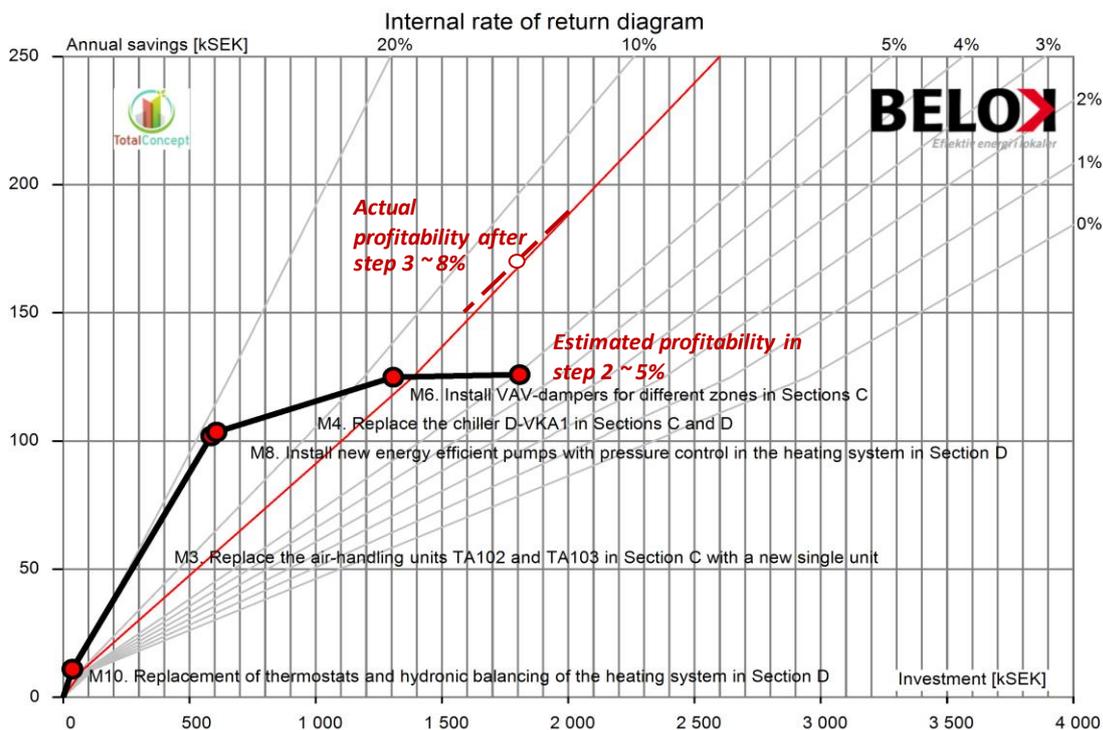
Figure 4.1. Outcomes of the profitability of the action package carried out in the Högsbo 20:22 office building presented in an internal rate of return diagram. Actual internal rate of return for the action package is about 8%.

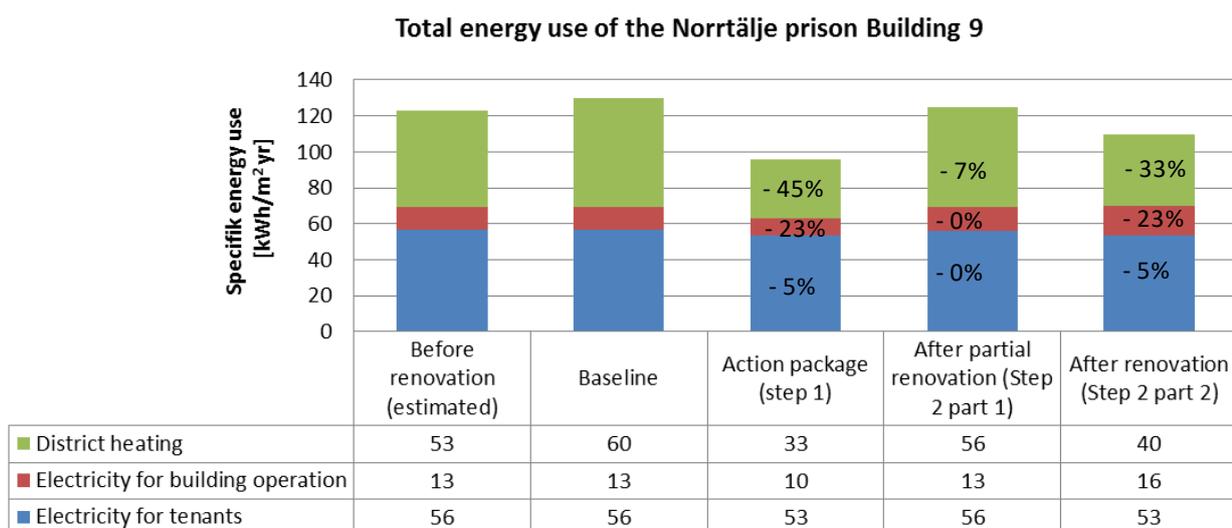
Figure 5.1 Estimated outcomes of Step 2 in Norrtälje prison building 9 compared to calculations made in Step 1.

Figure 5.1 presents the preliminary outcomes of Step 2 compared to estimated baseline in Step 1. Only few measures have been carried out so far from the proposed action package. Step 2 will be ongoing also in 2017.

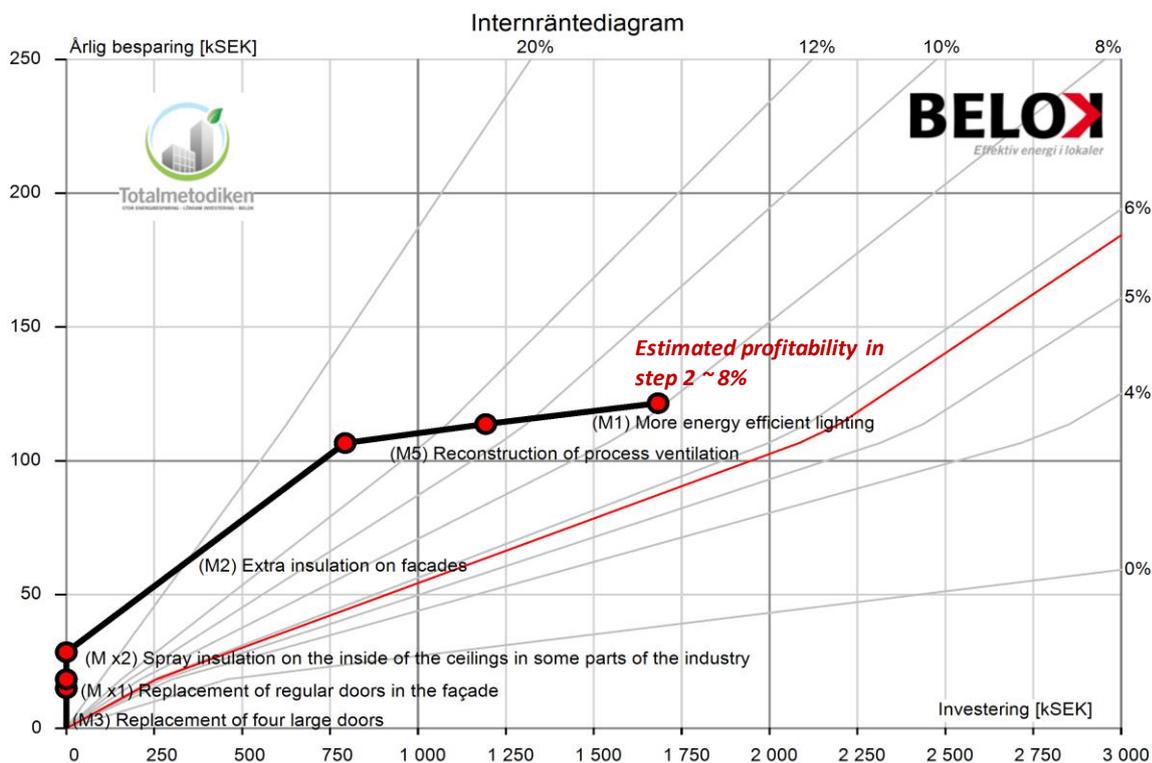
Figure 5.2. Calculated profitability of the action package in Step 2 in the Norrtälje prison presented in an internal rate of return diagram. The property owner's profitability requirement is 5.7% and the estimated relative energy price increase is 2%. The calculated profitability for the package in Step 2 is 8.1%.

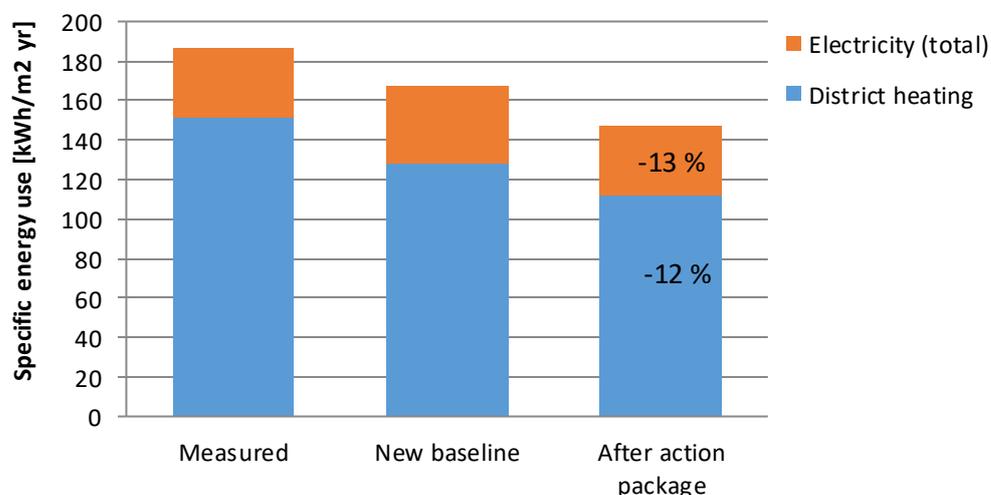
Figure 6.1 Outcomes of Step 1 in the Segevångs school property.

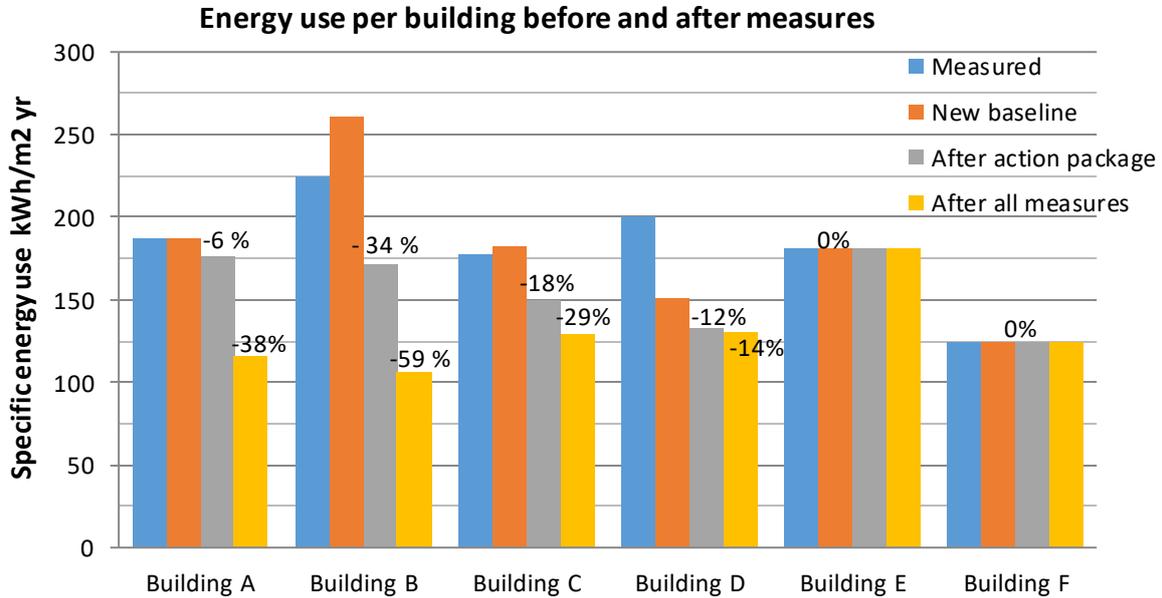
Figure 6.2 Outcomes of Step 1 in the Segevångs school property.

In Building A the energy saving potential with the action package is about 6%, in Building B about 34%, in Building C about 18% and in Building D about 12%. The internal rate of return of the proposed action package is 2%. The property owner's profitability demand is 2%.

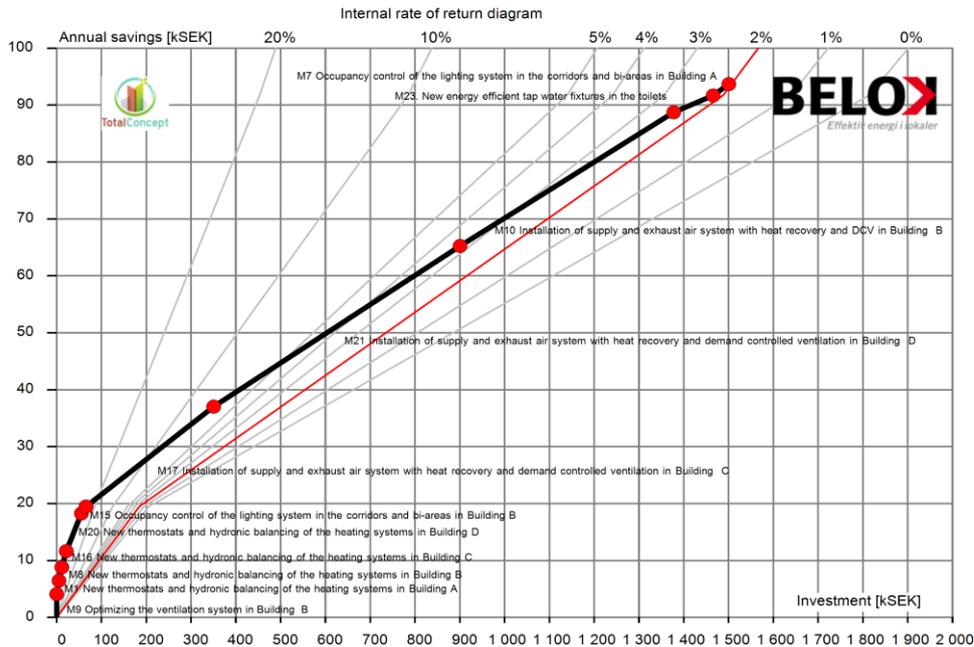
Figure 6.3. Calculated profitability of the action package in Step 1 in the Segevångs school property. The internal rate of return of the proposed action package is 2%. The property owner's profitability demand is 2% and relative energy price increase above inflation is estimated to be ca 1%.

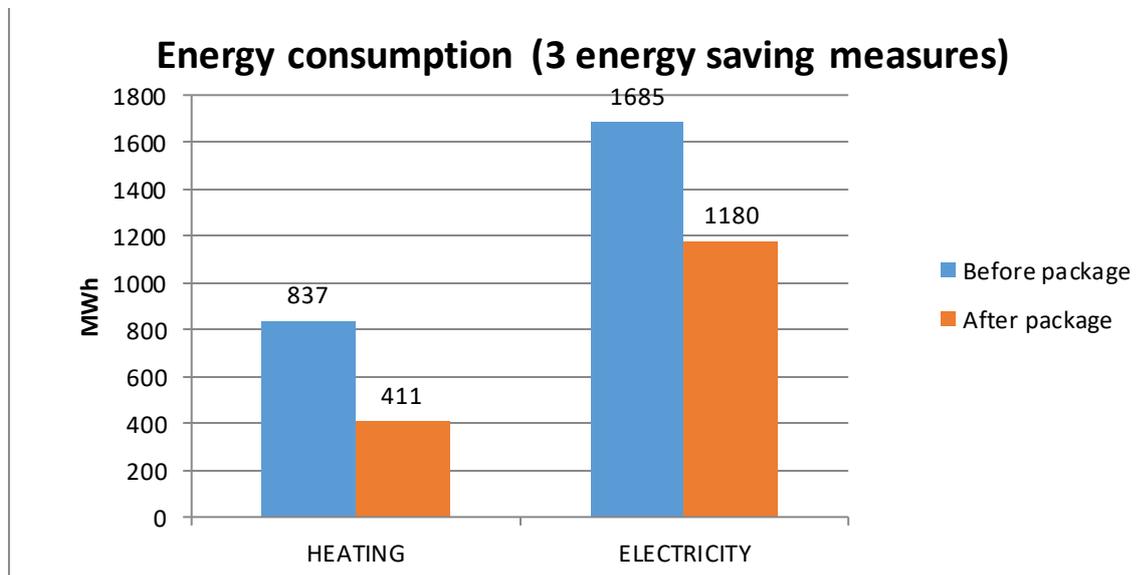
Figure 7.1 Energy use in Ballerup Town Hall when three measures are implemented.

Successful implementation of the action package will reduce energy use with 37% to a designed total energy use of 97 kWh/ m². The estimated energy saving is 50% for the heating energy and 30% for the electricity (see figure 7.1)

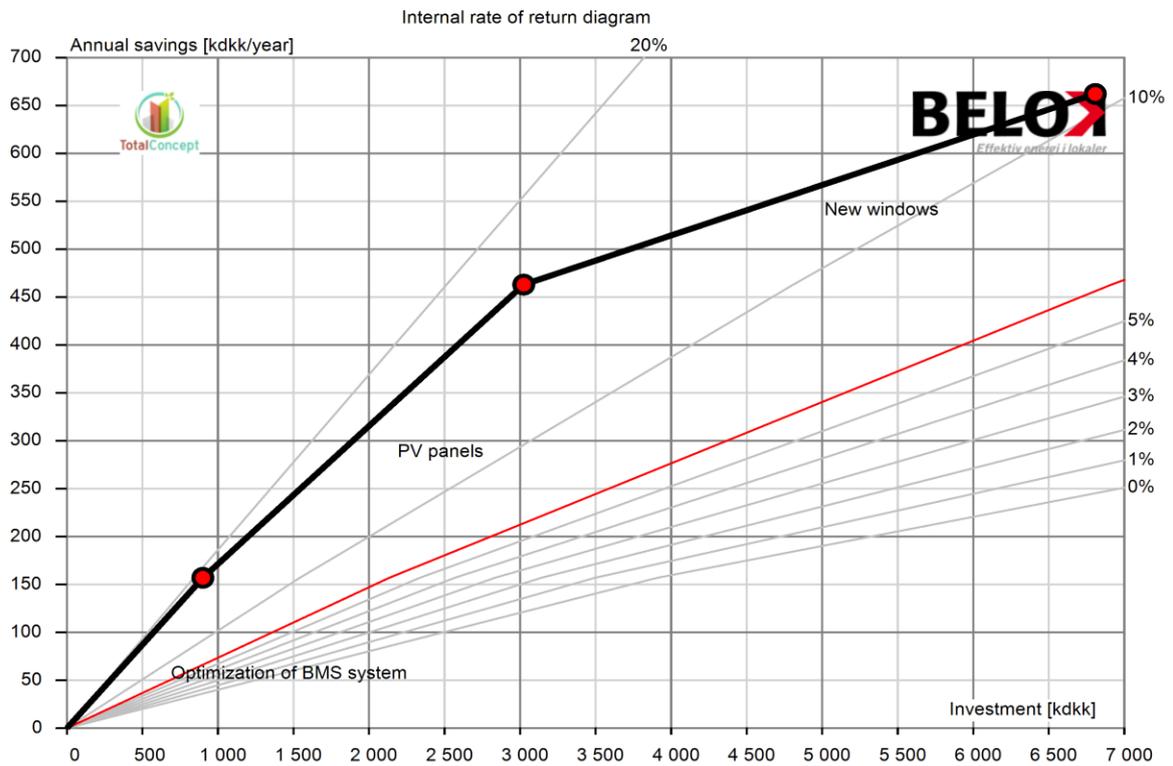
Figure 7.2. Outcomes of the profitability of the action package carried out in the Ballerup Town Hall building presented in an internal rate of return diagram. Estimated internal rate of return for the action package is approx. 10%.

The action package identified in step 1 would result in an IRR of approximately 10% (see figure 7.2).

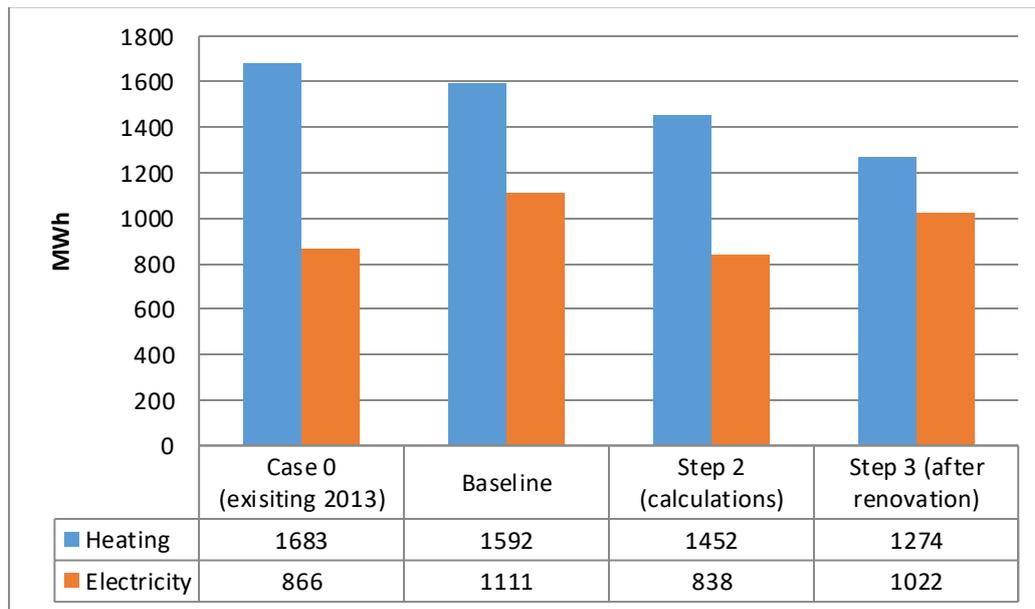
Figure 8.1 Energy use in Lyngby Port when four measures are implemented. Measurement outcomes in Step 3 compared to estimated baseline in Step 1 and calculated values in Step 2.

Figure 8.1 presents the measurement outcomes in Step 3 compared to estimated baseline in Step 1 and calculated values in Step 2.

The total heat energy use after renovations is about 1274 MWh (62 kWh/m²) per year (decrease by 19% comparing to the baseline's 77 kWh/m²). The estimation in Step 2 was 1452 MWh (70 kWh/m²) per year. The total electricity use after renovations is about 1022 MWh (50 kWh/m²) per year (decrease by 8% comparing to the baseline's 54 kWh/m²). The estimation in Step 2 was about 838 MWh (41 kWh/m²) per year. The missing saving is likely to be due to higher electricity use for ventilation. There are two probable reasons for this: higher occupation rates are handled with more air instead of lower temperature (this was priority programmed in the BMS then we checked) as well as higher pressure loss in the ventilation units than originally calculated. The high pressure loss in the ventilation units will be reduced by increasing size of openings after ventilators as well as removing unnecessary bendings after the air handling units. This is planned to be carried out in March 2017 (including measurements before and after).

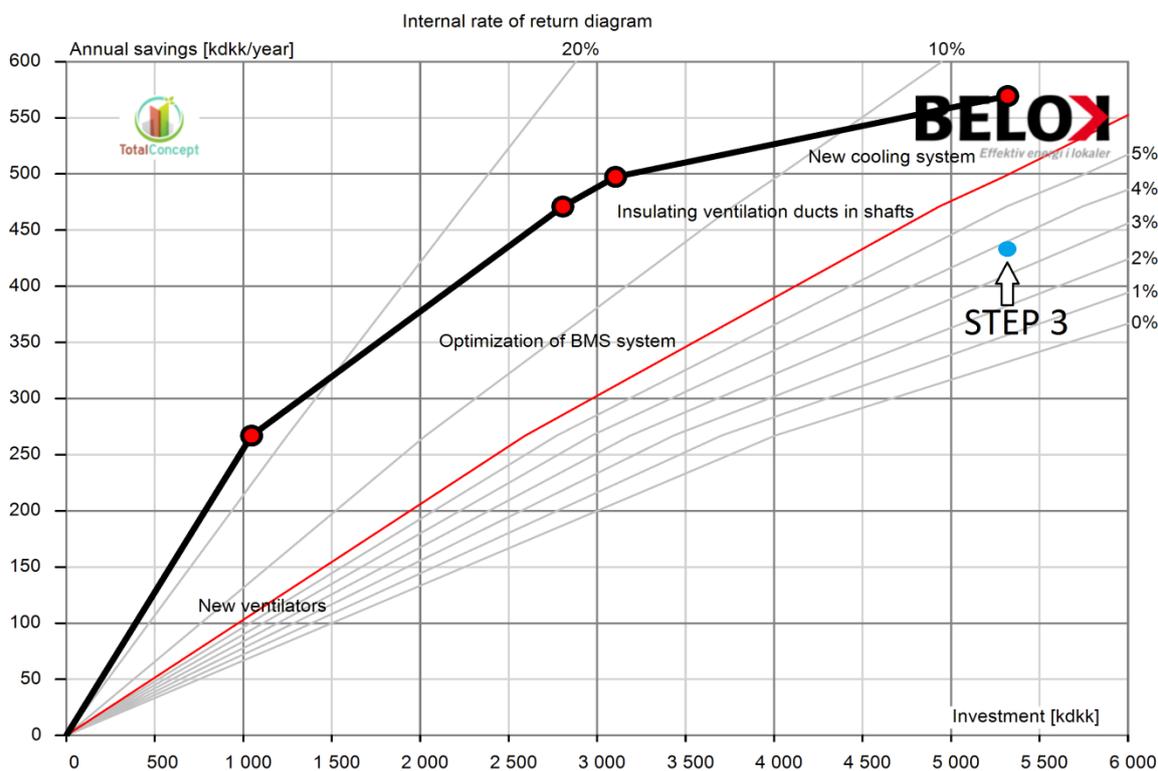
Figure 8.2. Outcomes of the profitability of the action package carried out in the Lyngby Port office building presented in an internal rate of return diagram. Estimated internal rate of return for the action package after Step 3 is approx. 4%.

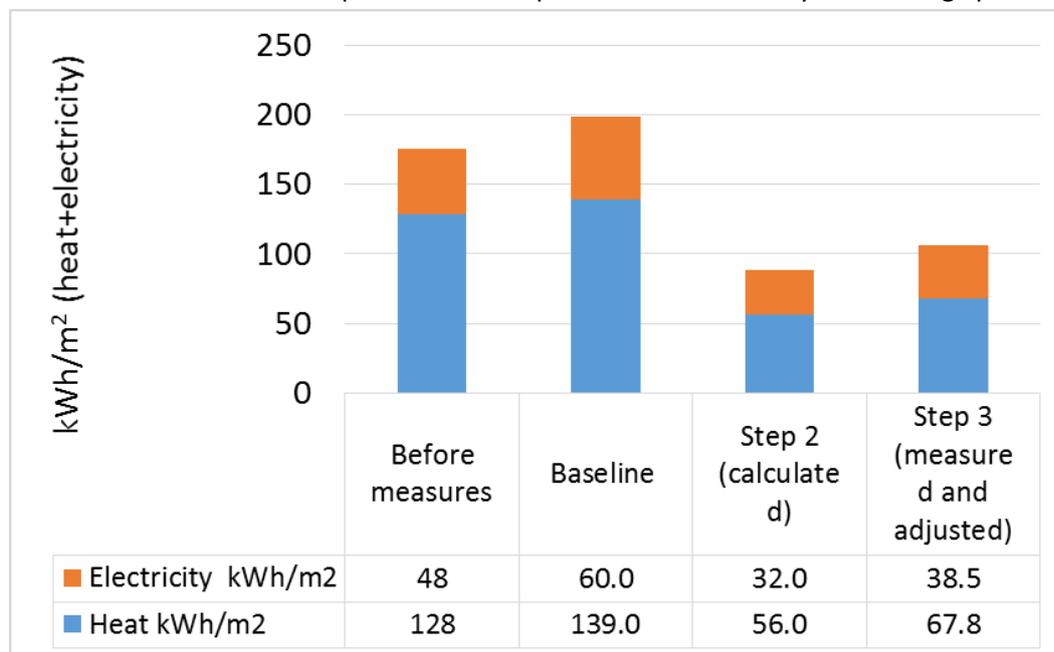
Figure 9.1 Estimated outcome in Step 3 compared to baseline.

Figure 9.1 presents the measurement outcomes in Step 3 compared to estimated baseline in Step 1 and calculated values in Step 2. There is no split between electricity for building operation and tenants.

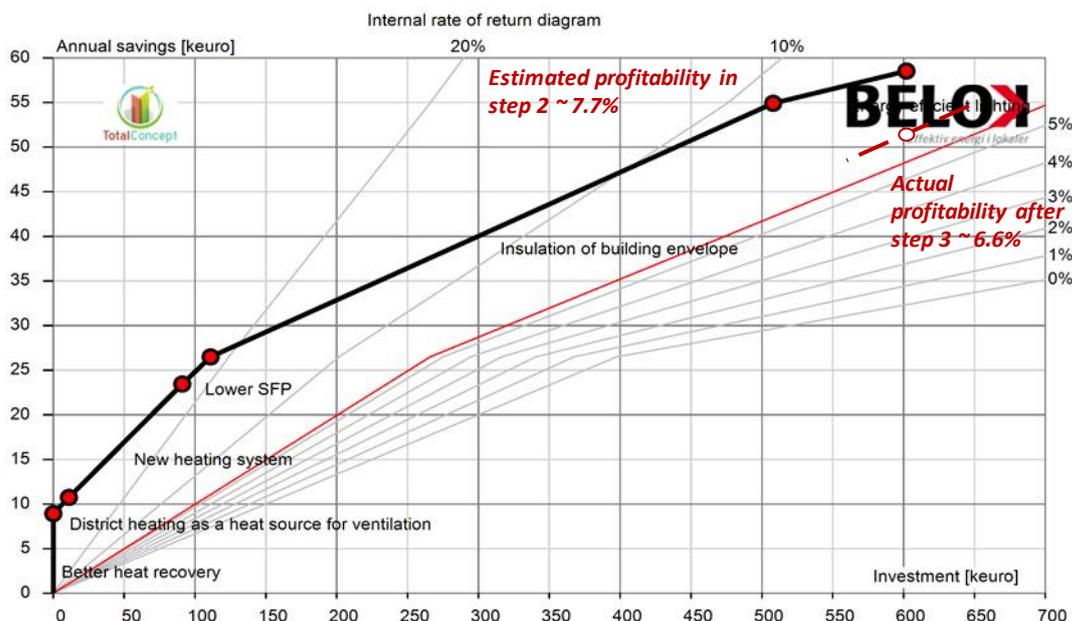
Figure 9.2 Outcomes of the profitability of the action package carried out at the Pärnu School building. Relative energy price increase is 2%.

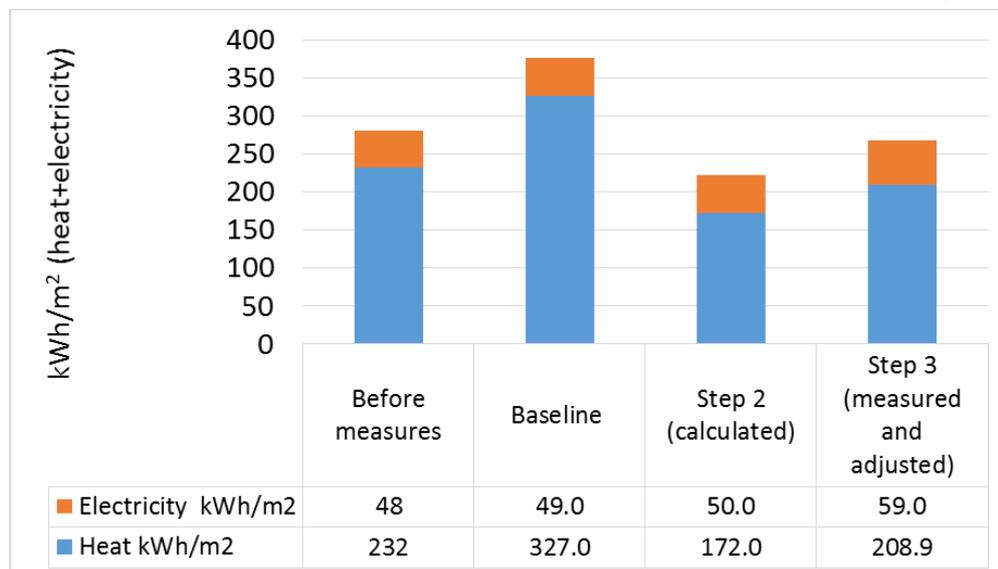
Figure 10.1. Estimated outcome in Step 3 compared to baseline.

Figure 10.1 presents the measurement outcomes in Step 3 compared to estimated baseline in Step 1 and calculated values in Step 2. There is no split between electricity for building operation and tenants.

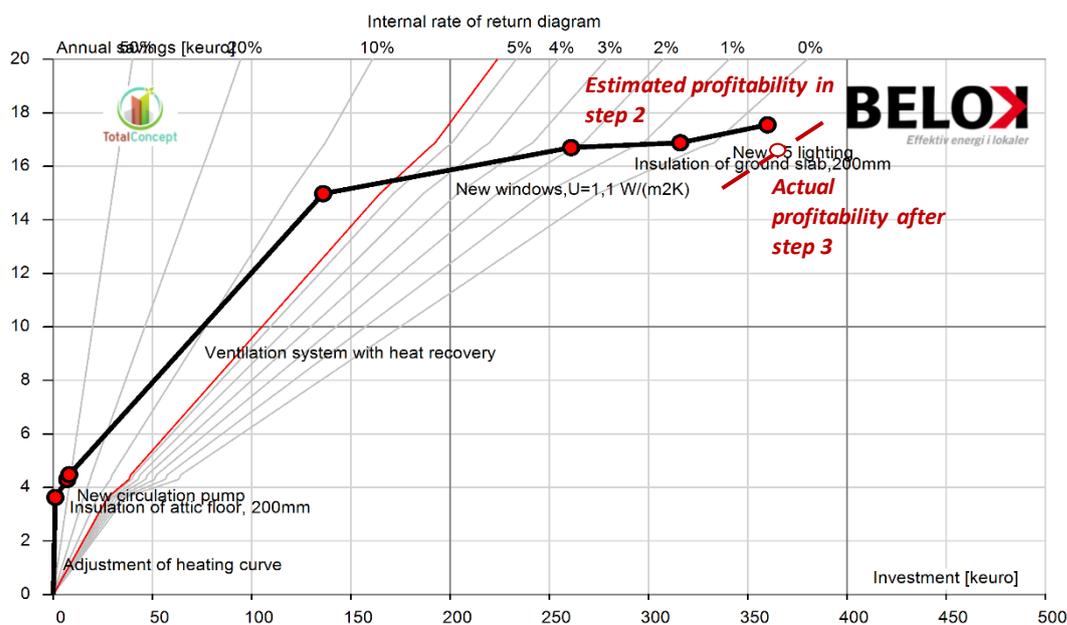
Figure 10.2 Outcomes of the profitability of the action package carried out at the Kiriku 2-4. Tallinn office building. Relative energy price increase is 2%. Actual internal rate of return for the action package is negative.

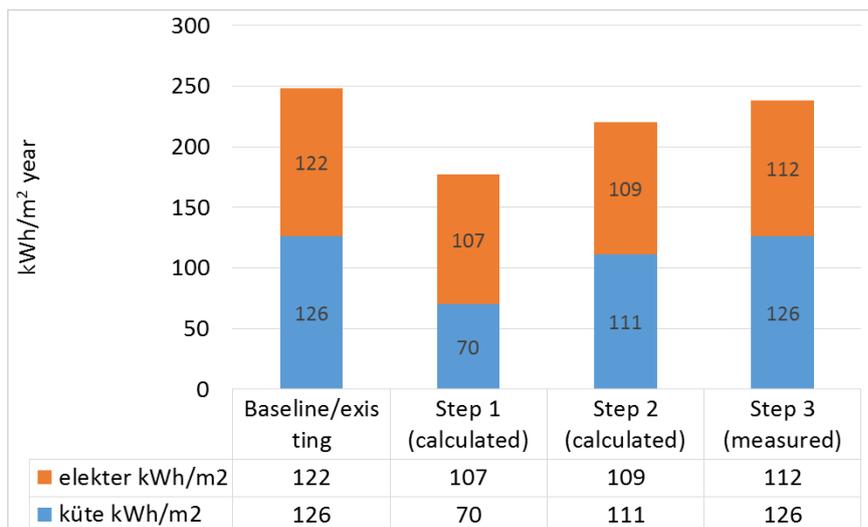
Figure 11.1 Estimated outcome in Step 3 compared to baseline. Elekter means electric energy and küte means thermal energy.

Figure 11.1 presents the measurement outcomes in Step 3 compared to estimated baseline in Step 1 and calculated values in Step 2. There is no split between electricity for building operation and tenants.

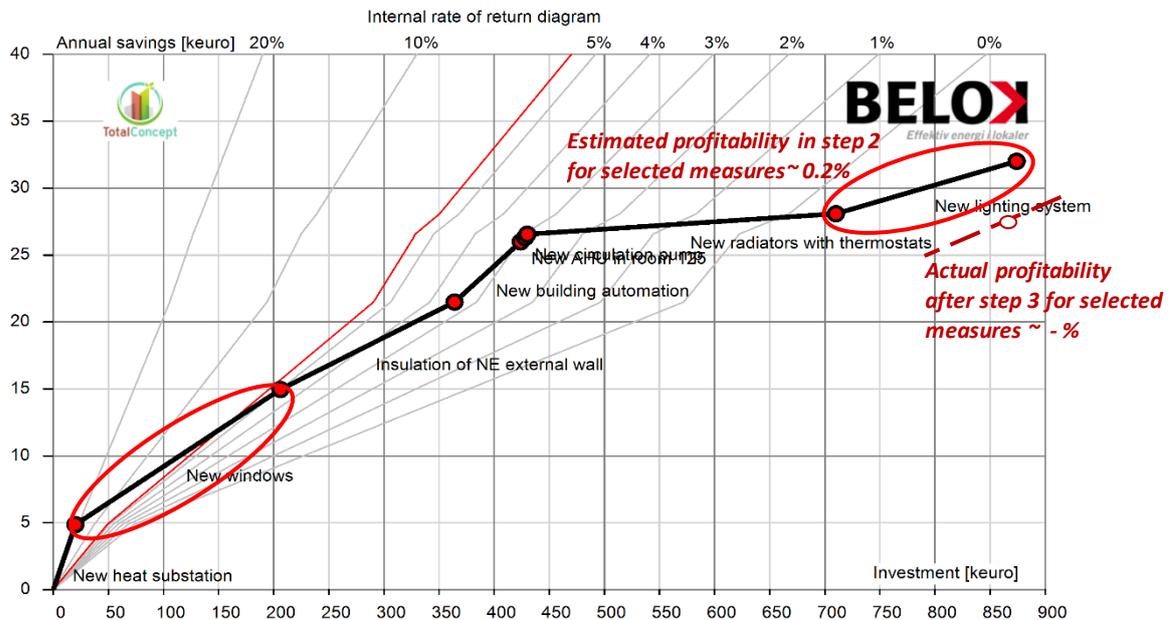
Figure 11.2 Outcomes of the profitability of the action package carried out at the Gonsiori 29. Relative energy price increase is 2%. Actual internal rate of return for the action package is negative.

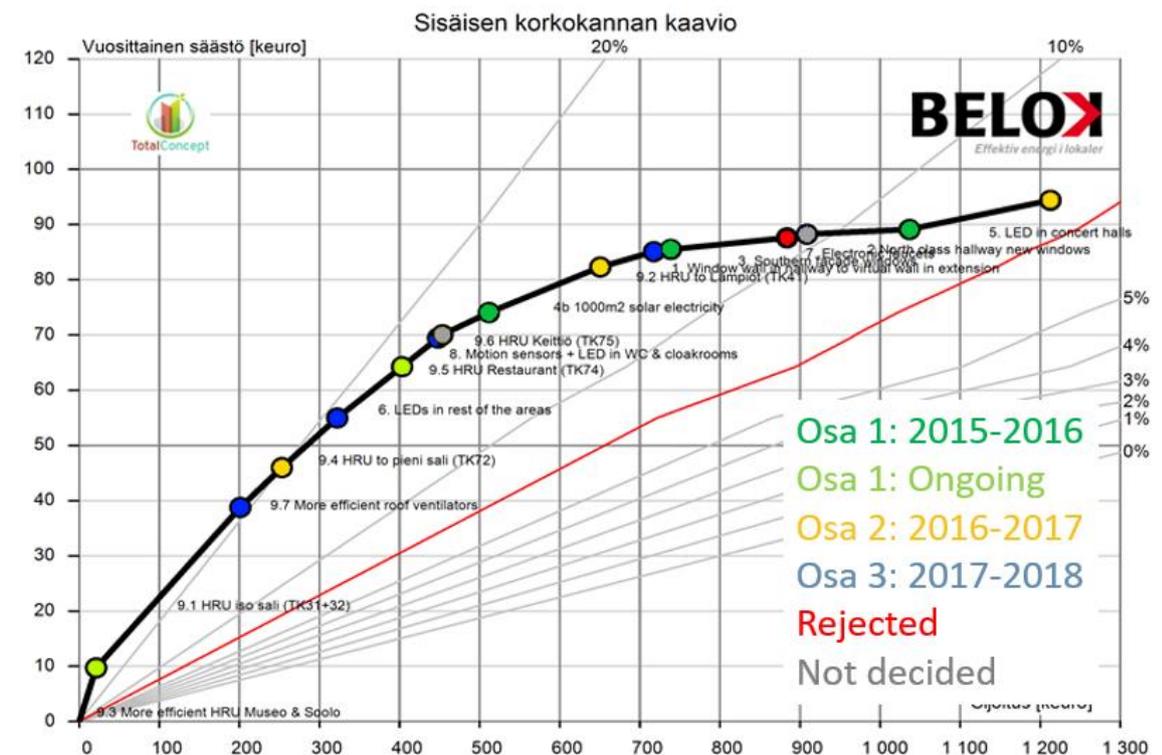
Figure 12.1. The proposed measures and the different phases of the sequencing of the renovation. Measure 1, 2 and 9.6 were completed in 2016. Measure 6 and 9.3 are ongoing and planned to be finalized in 2017. Measure 3 has been rejected. The other eight measures are planned to be completed in 2019.

After Step 1, seven measures, listed in chapter 12.2, were implemented in part 1 of the renovation. Measure 1, 2 and 9.6 were completed in 2016. Measure 6 and 9.3 are ongoing and planned to be finalized in 2017. Measure 3 has been rejected. The other eight measures are planned to be completed in 2019. The energy consumption is estimated to decrease 23% to 142 kWh/m².

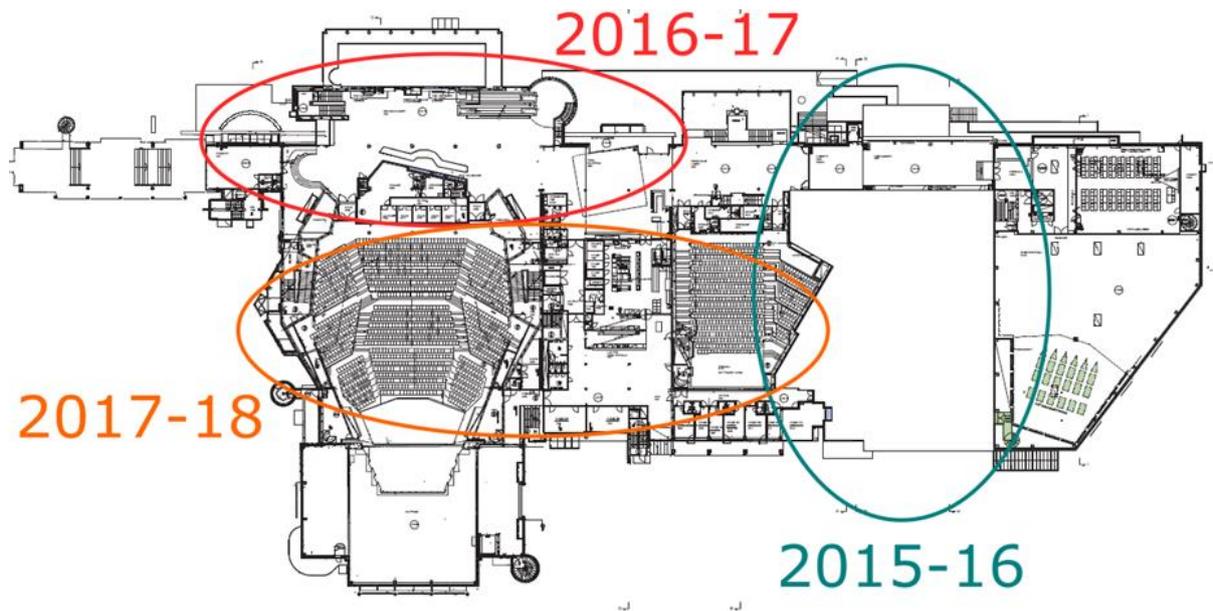
Figure 12.2 Overview of building areas. The action package is divided in three parts. Measure 1, 2 and 9.6 is in part 1 marked 2015-2016. Measure 6 and 9.3 are in part 2 marked -2016-2017. Measure 3 has been rejected. The other eight measures are in part 3 marked 2017-2018.

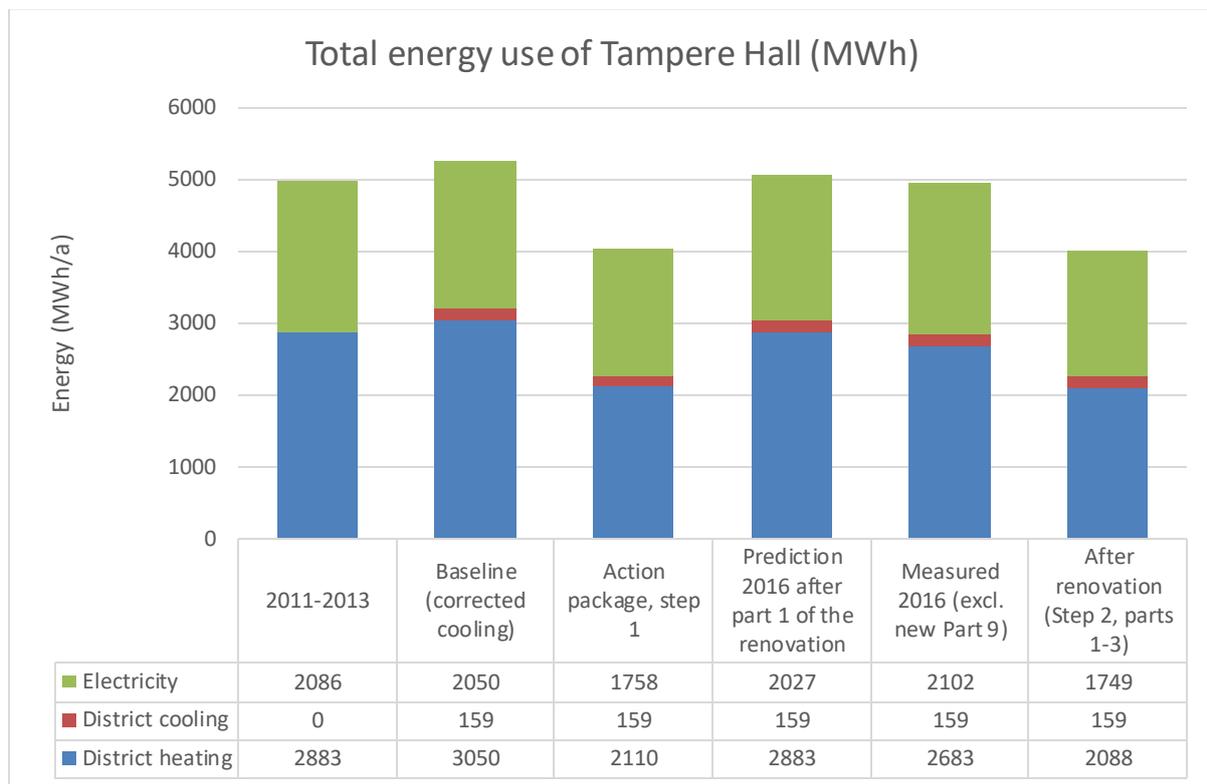
Figure 12.3 Energy use after different stages of the action package. Measure 1, 2 and 9.6 has been carried out and measured (column "Measured 2016") and compared with predicted energy use (column "Prediction 2016 after part 1 in Figure 12.2"). Part 9 is new built extension between Sorsapuisto hall and the main building and this is not included.

Figure 12.3 shows the outcomes of the latest measured step compared to estimated baseline in Step 1 and the estimation of the final result once the building renovation has been completed.

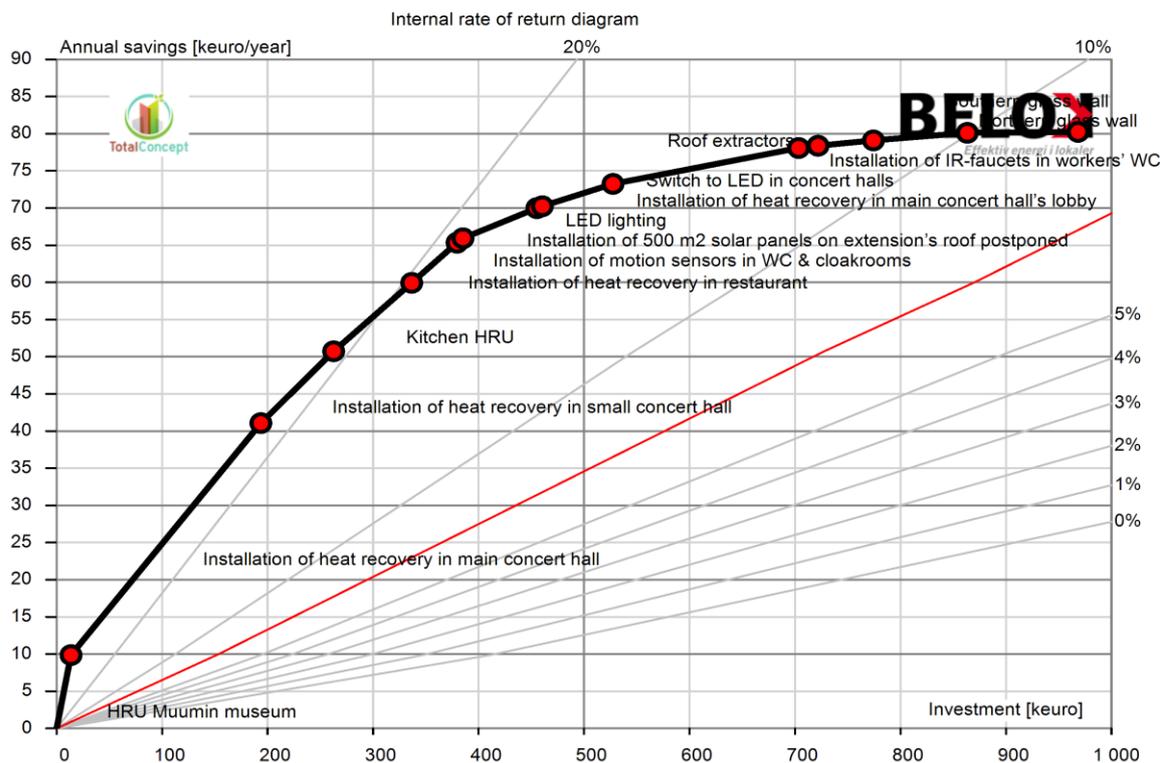
Figure 12.4. Outcomes of the profitability of the action package carried out at the Tampere Hall. The internal rate of return after for part 1-3 of Step 2 is completed is estimated to be approximately 8.5%.

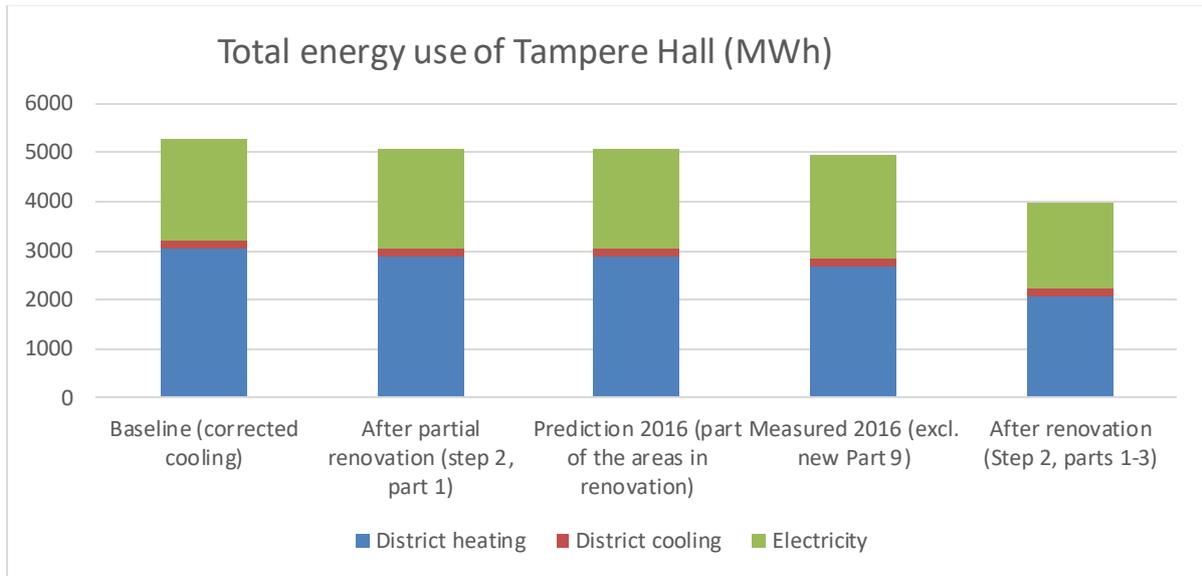
Figure 12.5 Overview of the total energy consumption in baseline, the estimated consumption of the package 1 implemented (October 2016) and the actual consumption in 2016.
